# ***Overview of Landslides in Southern Maine and the September 16, 2020 Westbrook Landslide***

Lindsay Theis  
Senior Geologist  
Maine Geological Survey  
[lindsay.theis@maine.gov](mailto:lindsay.theis@maine.gov)

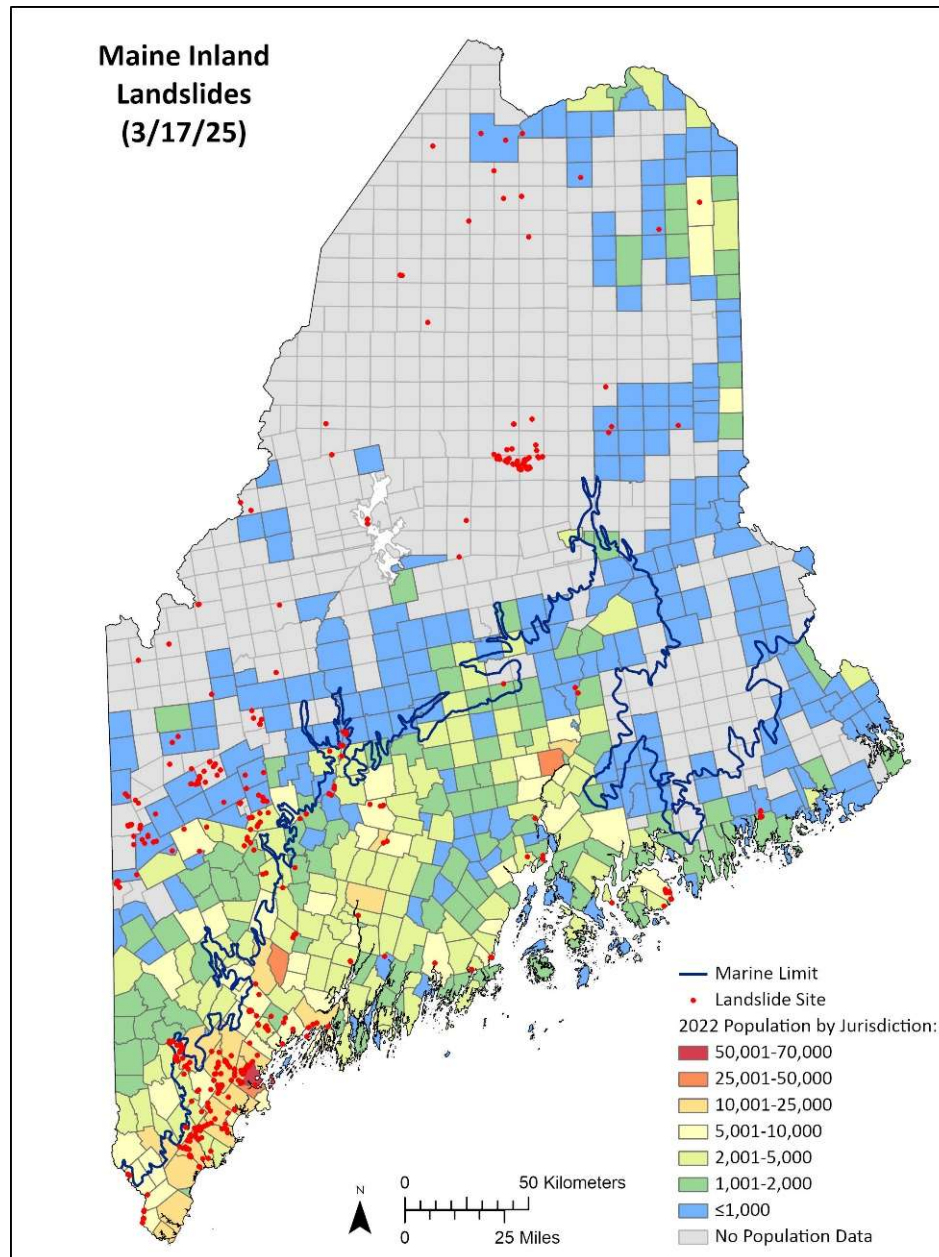
## Current Inland Landslide Inventory

- **447** inland landslides:
  - **238** below marine limit (most related to Presumpscot Formation).
  - Highest density in most populated area of the state.

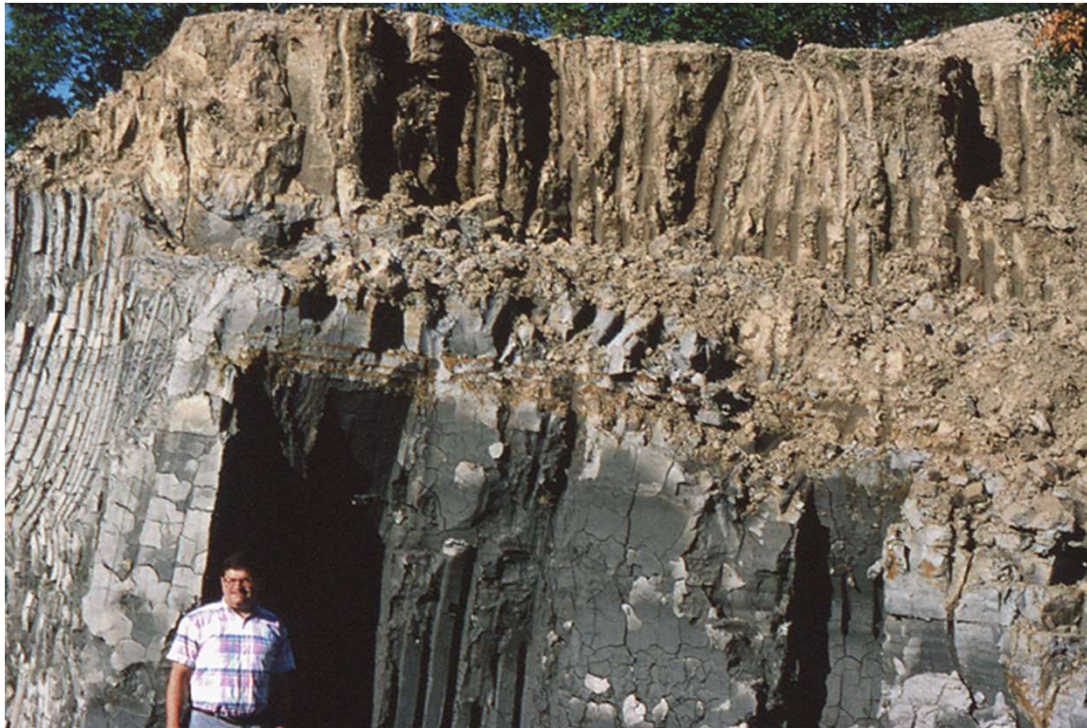
**Presumpscot Formation exposure, south-central Maine.**

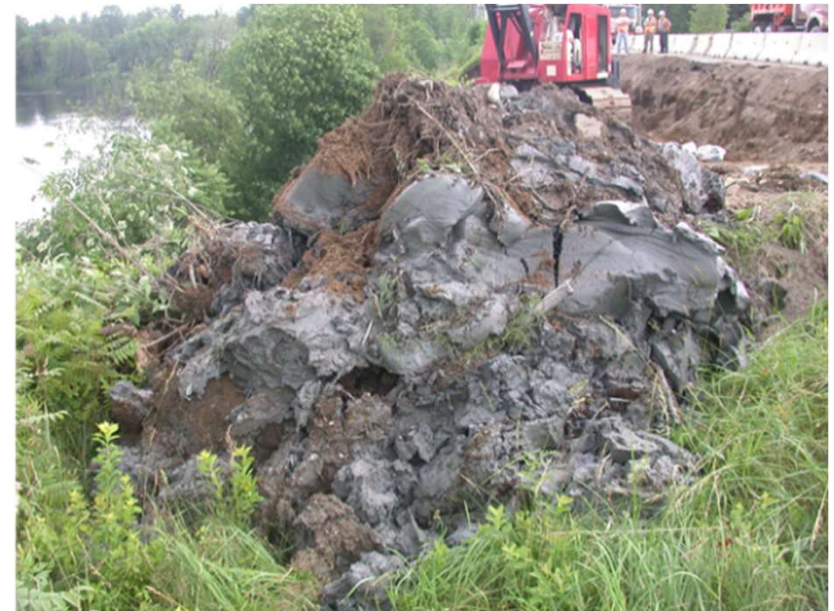
**Soft Presumpscot Formation removed from landslide site along Penobscot River.**

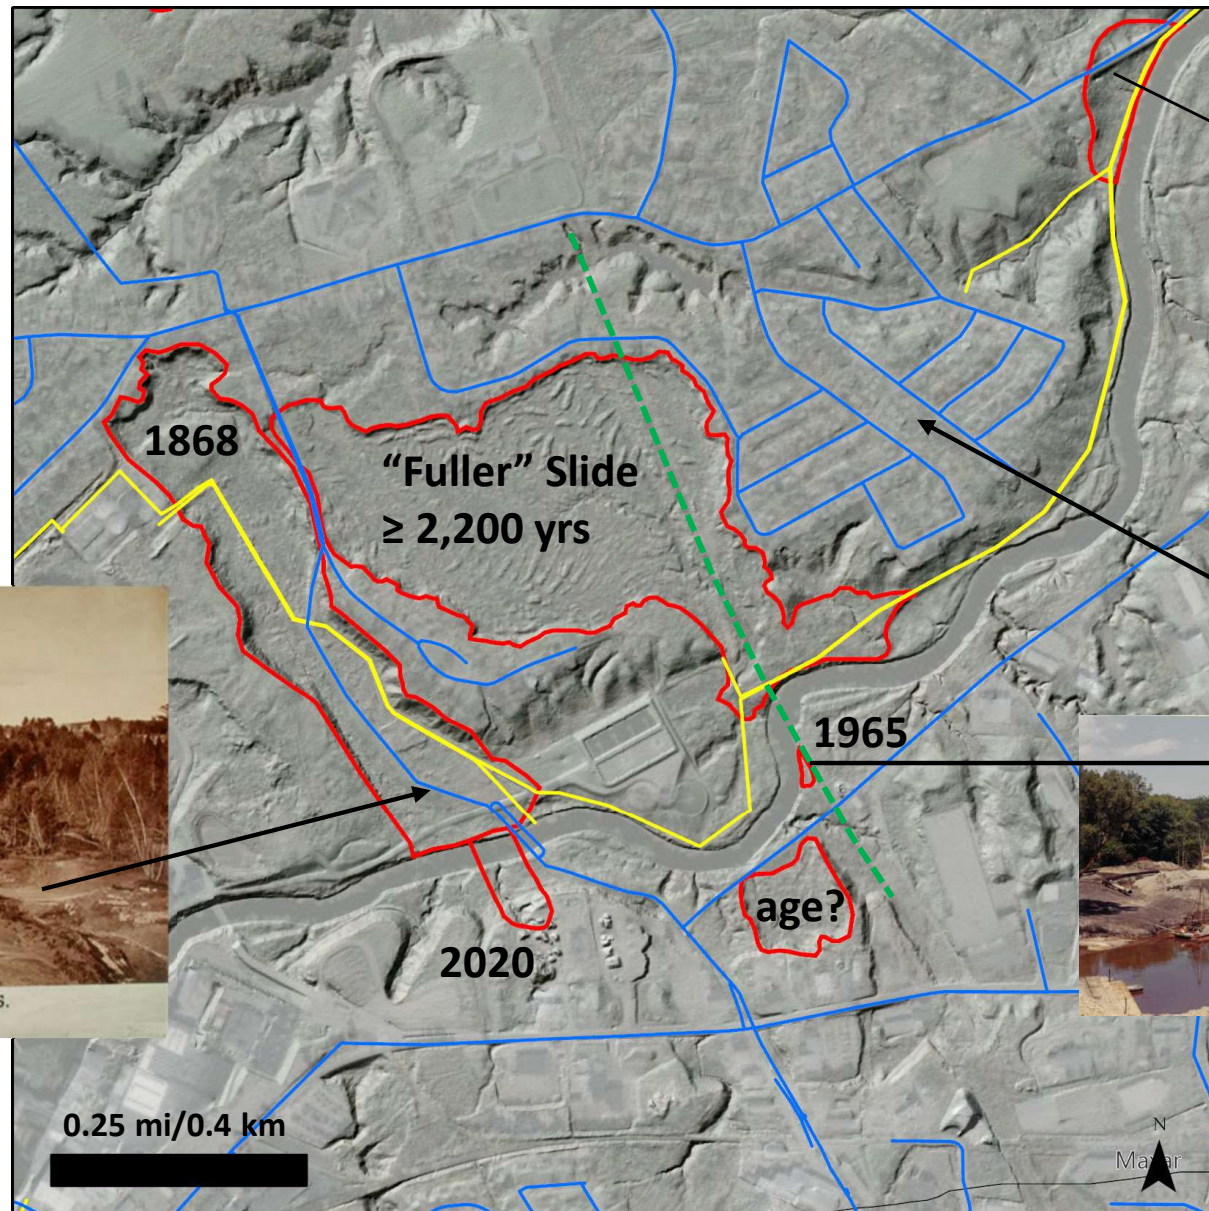
Local Context: Westbrook 2020 Event**Line legend:**

- **Red:** Landslide Extents
- **Blue:** Water
- **Yellow:** Sewer
- **Green:** Gas (approx.)
